# CES Environmental Services Hazardous Waste Site

By Jim Blackburn  
Rice University

Civil and Environmental Engineering Department  
July 5, 2016

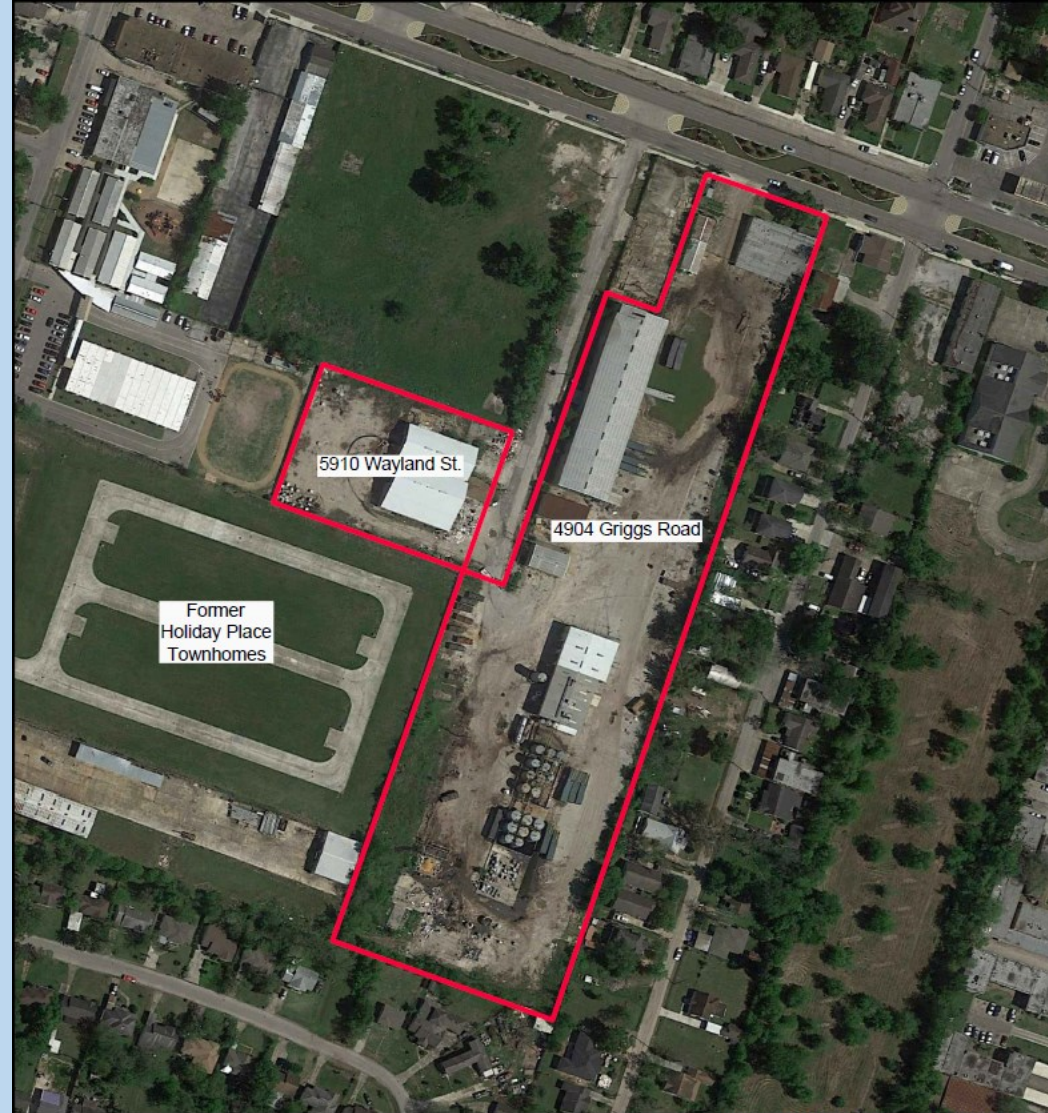
Figure 2

CES ENVIRONMENTAL SERVICES  
4904 GRIGGS ROAD  
HOUSTON, TEXAS

**SITE MAP**

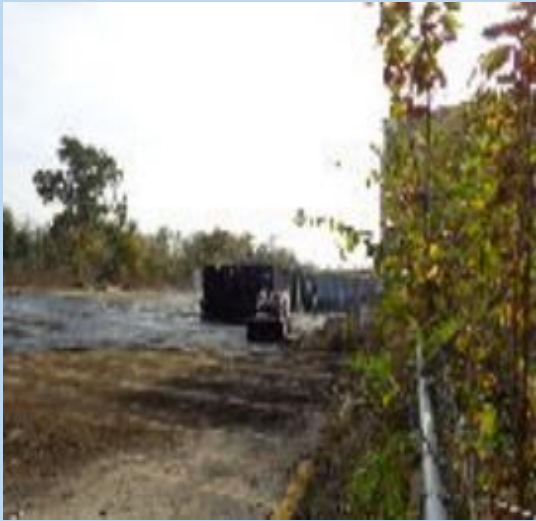
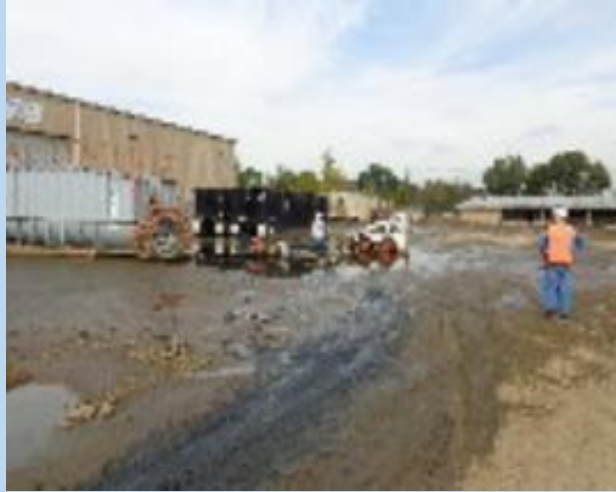
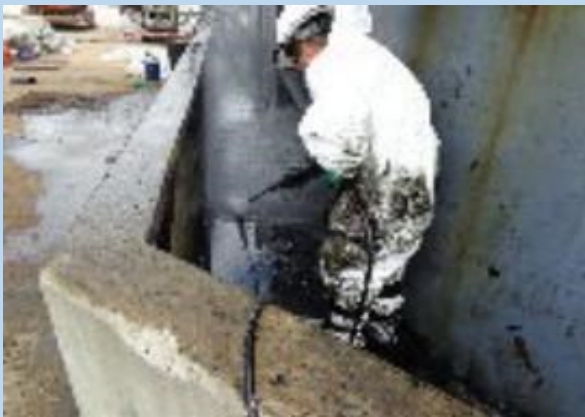
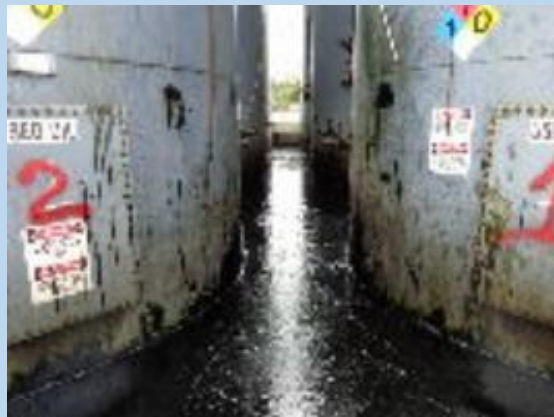
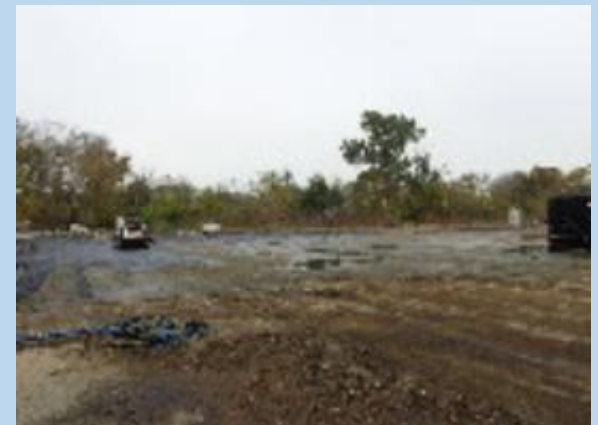
# Photos From EPA Site Clean-up

**Removal of materials that had flowed off-site**

**Flushing storm sewers**

**Removed oily materials from on-site ponded areas**

**Construction of berms to prevent further releases off-site**

**Removal and disposal of more than 3000 tons of waste materials  
from tanks, sumps, roll-off boxes, drums, totes and other  
containers**

**Visibly contaminated soils were removed to eliminate sheen on  
storm water**

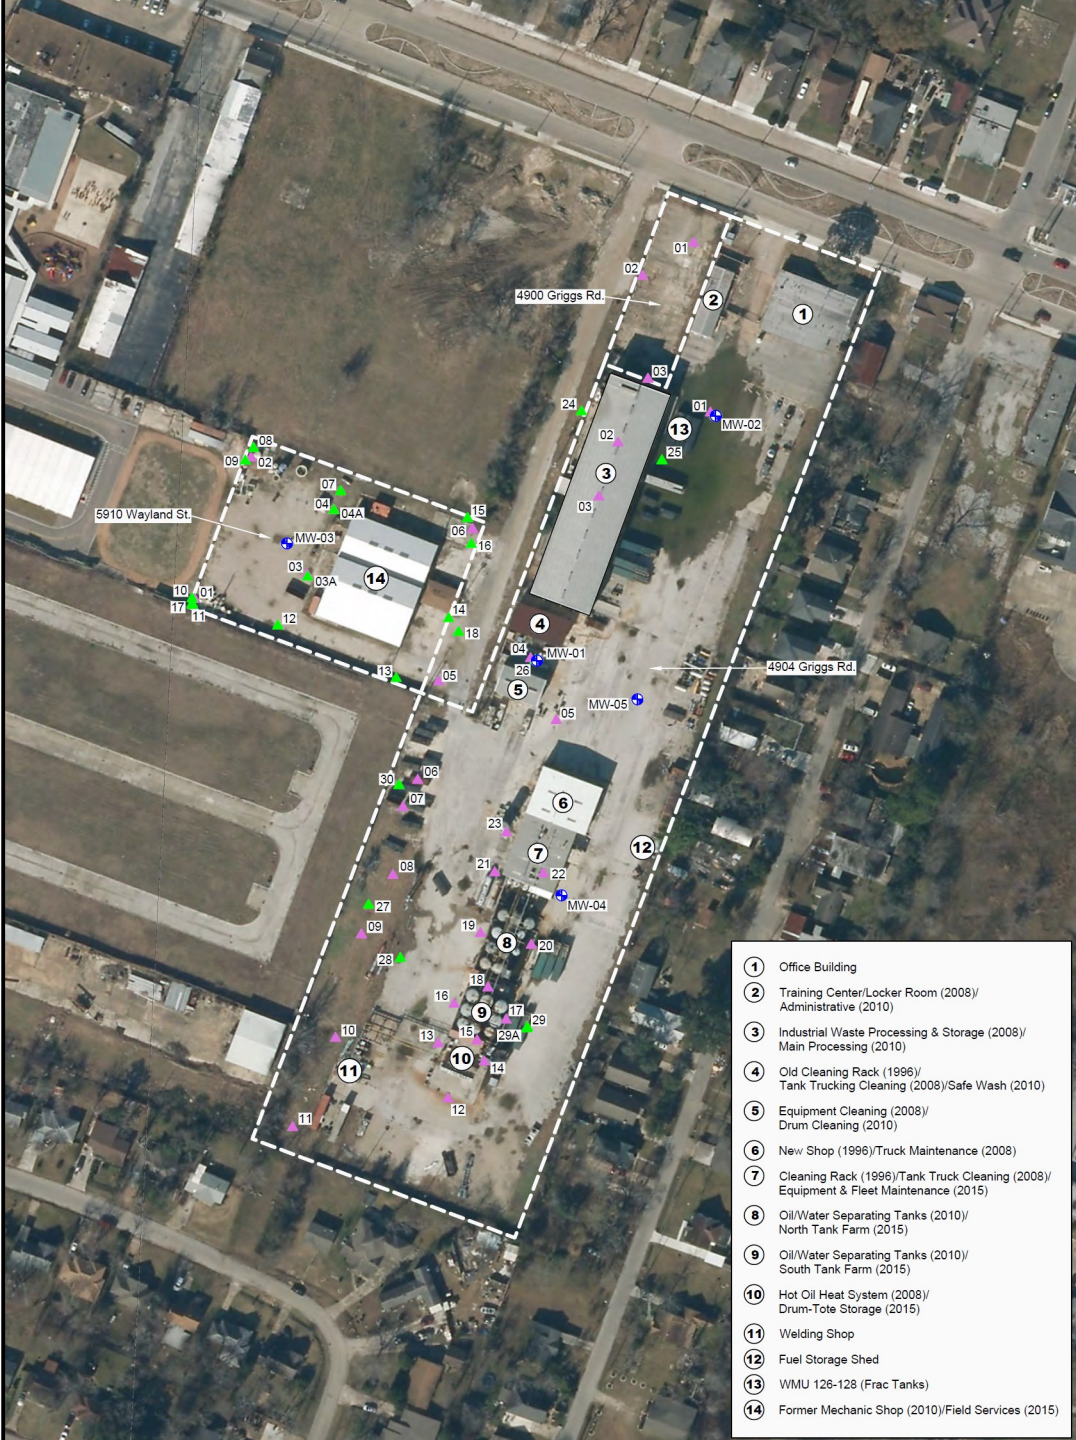
Figure 1A

PBW Sample Location - Phase I
-

PBW Sample Location - Phase II
-

PBW Monitoring Well Location

**ON-SITE PROPERTY MAP**

- ① Office Building
- ② Training Center/Locker Room (2008)/  
Administrative (2010)
- ③ Industrial Waste Processing & Storage (2008)/  
Main Processing (2010)
- ④ Old Cleaning Rack (1996)/  
Tank Trucking Cleaning (2008)/Safe Wash (2010)
- ⑤ Equipment Cleaning (2008)/  
Drum Cleaning (2010)
- ⑥ New Shop (1996)/Truck Maintenance (2008)
- ⑦ Cleaning Rack (1996)/Tank Truck Cleaning (2008)/  
Equipment & Fleet Maintenance (2015)
- ⑧ Oil/Water Separating Tanks (2010)/  
North Tank Farm (2015)
- ⑨ Oil/Water Separating Tanks (2010)/  
South Tank Farm (2015)
- ⑩ Hot Oil Heat System (2008)/  
Drum-Tote Storage (2015)
- ⑪ Welding Shop
- ⑫ Fuel Storage Shed
- ⑬ WMU 126-128 (Frac Tanks)
- ⑭ Former Mechanic Shop (2010)/Field Services (2015)

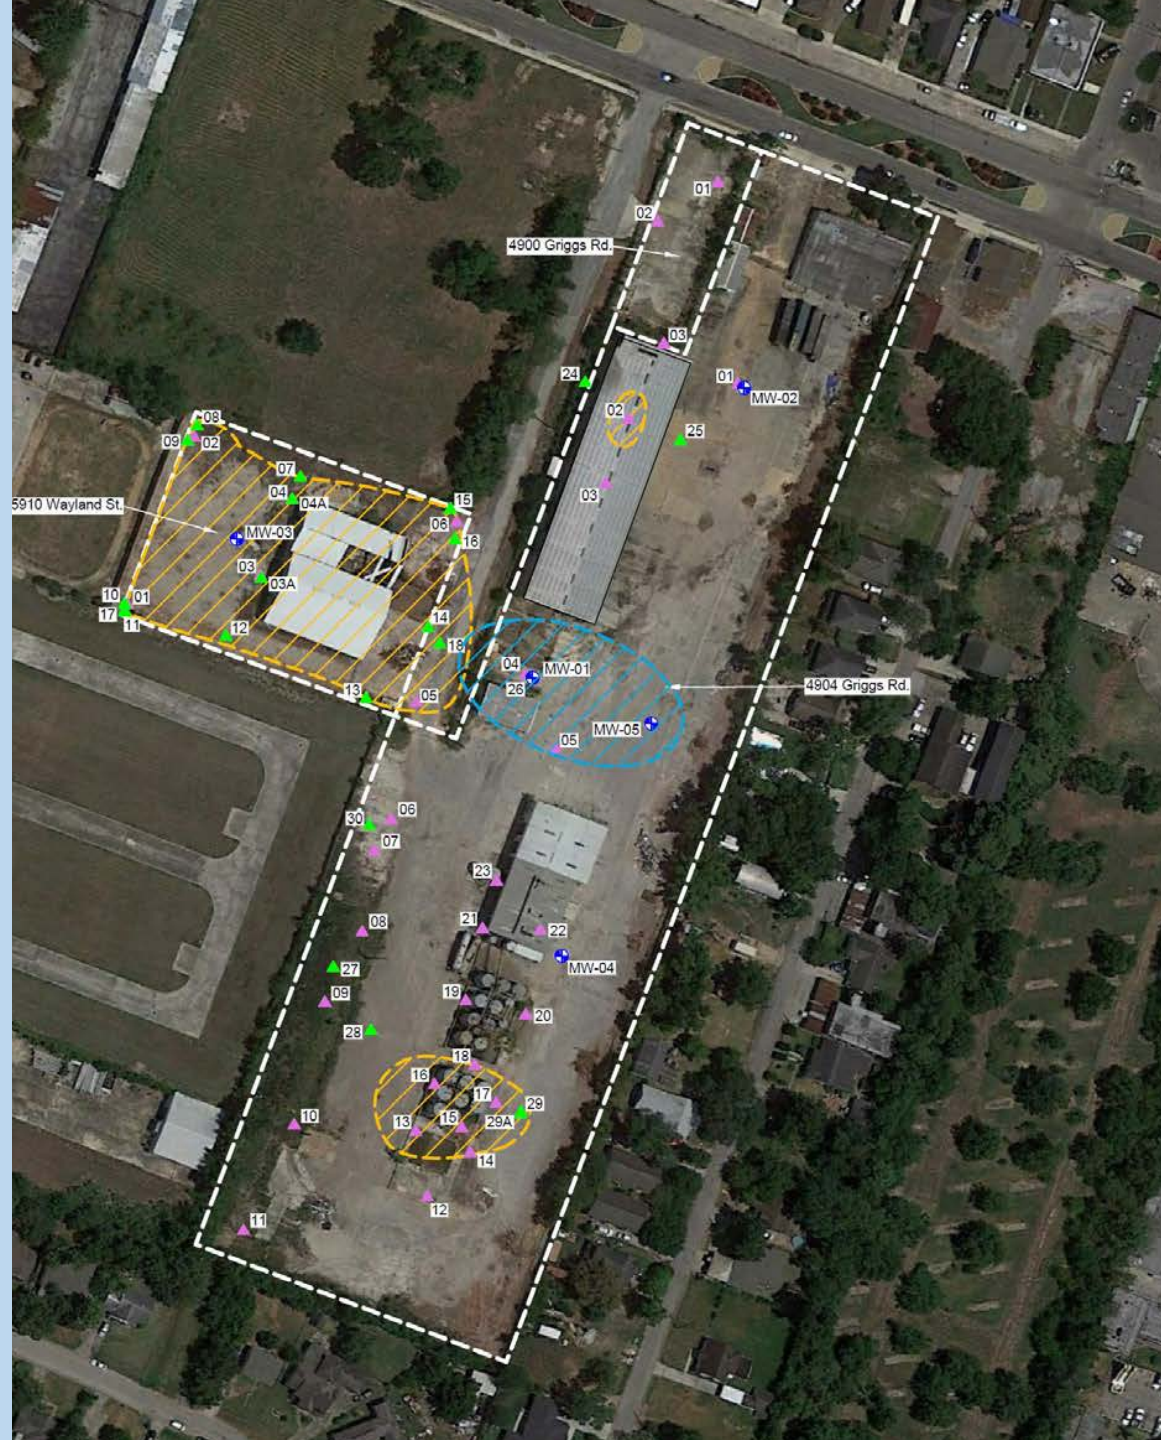
Figure 1B shows the Site and areas where manganese, vanadium, benzo(a)pyrene, and petroleum hydrocarbon detected in soils and the CVOCs detected in groundwater exceed the TCEQ residential standards.
